Investigation Report

Department of Health

ID #: PA0991B

Facility: Waste Management Hawaii/ CCH

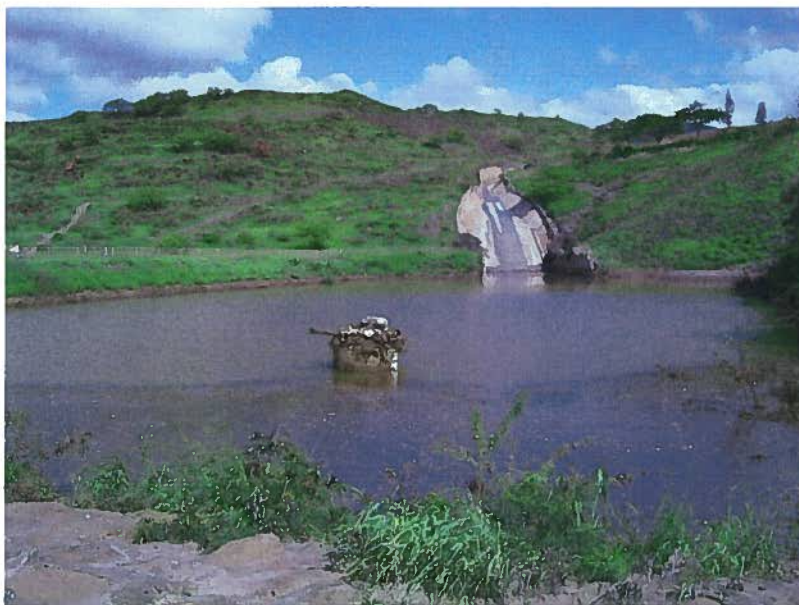
Photograph # 1

- 2) The Landfill's detention basin (Photograph 1) was full of turbid water at the time inspection. The Landfill pumped storm water which had contacted municipal solid waste in the E6 cell into the detention basin between December 19, 2010 and December 23, 2010. According to both J. Lottig and J. Frey, no pumping of storm water, leachate, or potentially contaminated storm water from the E6 cell into the detention basin had been conducted since December 23, 2010.

Description: View of the detention basin, from the detention basin's berm. The detention basin was filled with highly turbid water at the time of inspection.

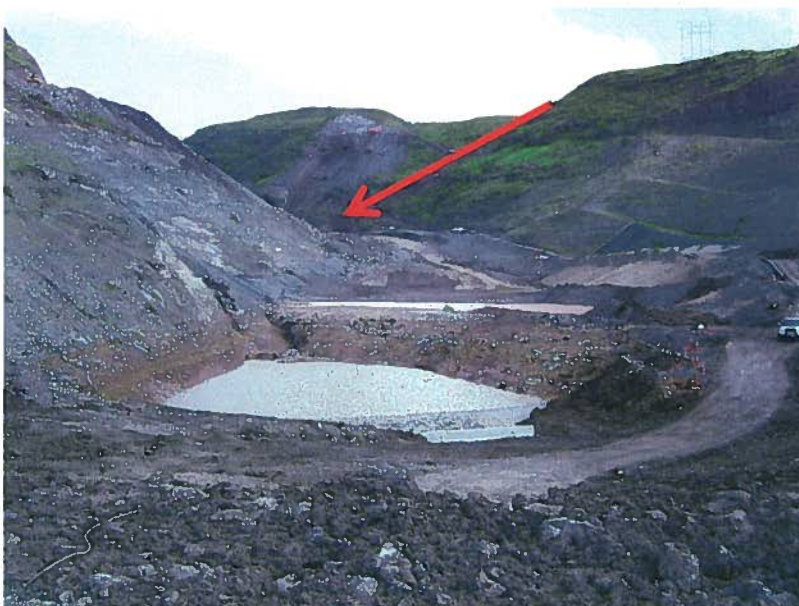
Photograph # 2

waste was observed comingled with the turbid water in the E6 cell. A high water mark (Photographs 2 and 4) was observed in the E6 cell. The water level observed (Photograph 4) appeared to have decreased significantly as the water level observed was much lower than the high water line. J. Lottig stated that the water level must have decreased due to evaporation and percolation.

Description: View facing north of the E6 cell from the cell's berm/dam. The 36-inch subsurface storm water inlet is located North of the E6 cell (Red Arrow). Significant amounts of water were still ponding within the E6 cell at the time of inspection.

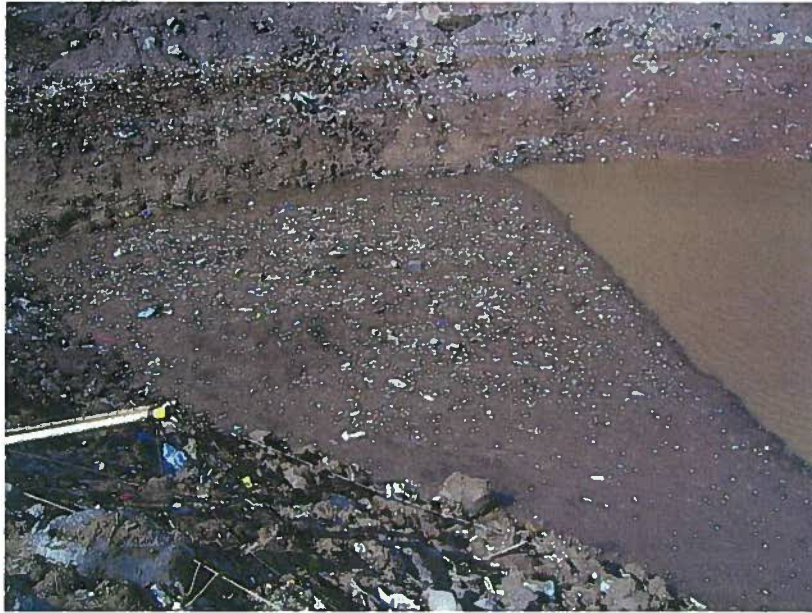
Photograph # 3

- 4) The water observed in the E6 cell appeared highly turbid at the time of the inspection. The top of the turbid water was partially covered with a layer of sludge-like debris which included solid waste (Photograph 3). Solid

Description: View of ponded water on the south side of the E6 cell. A layer of a sludge-like substance that included solid waste had accumulated on the top of the ponded water in the E6 cell. Solid waste water observed from the high water mark to observed water level.

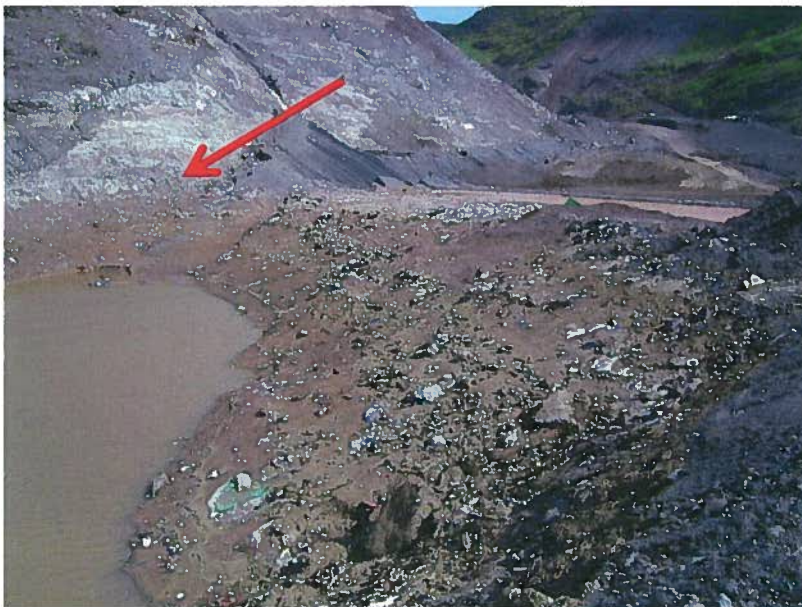
Photograph # 4

Description: View of the E6 cell. The water level in the E6 cell appeared to have decreased significantly as compared to the level indicated by the high water mark (Red Arrow).

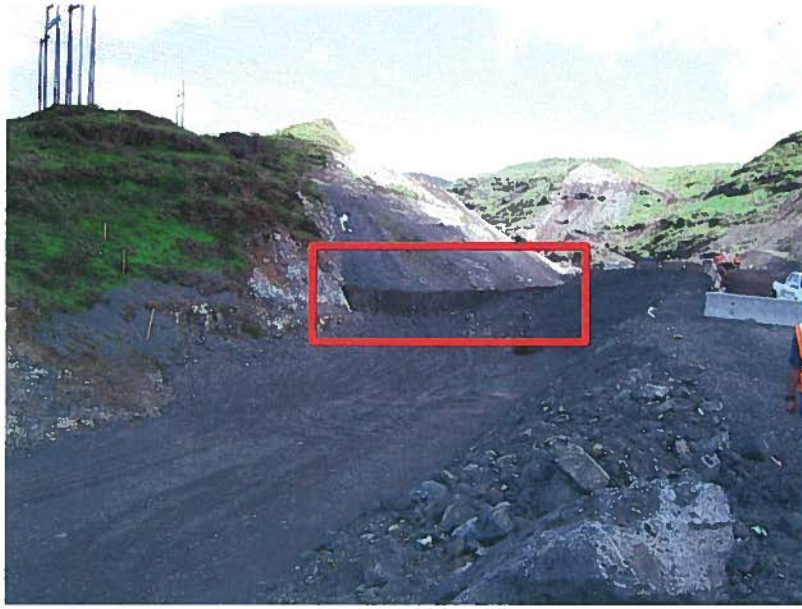
Photograph # 5

6) The southwest side of the E6 cell (Photograph 5) was delineated by an earthen berm/dam that was constructed to contain run-on if the E6 cell was again flooded. Downstream of the earthen berm/dam is a graded path that would channel discharges from the E6 cell to where Kahe Generating Station is located (Photograph 6) if the berm/dam failed. J. Frey and J. Lottig stated that in the event of a failure of the earthen berm/dam located on the southwest side of the E6 cell, the impounded water would flow down the graded path into the area directly above the Kahe Generating Station.

Description: View of the berm/dam (Red Box) on the southwest side of the E6 cell. In the event that the E6 cell floods, the berm/dam is the only structure that contains the water impounded in the E6 cell.

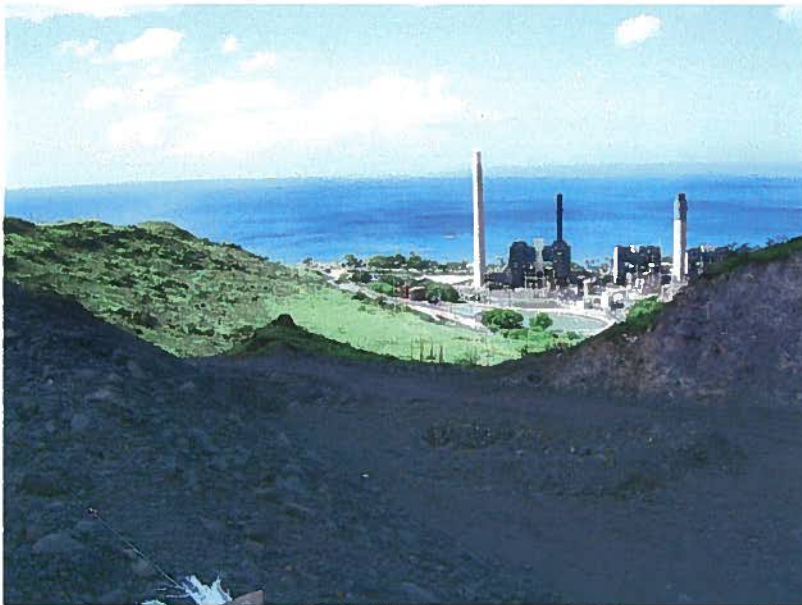
Photograph # 6

Description: View of a the graded path that connects the E6 cell to the Kahe Generating State valley. In the event of the E6 berm/dam failing, discharges from the E6 cell would flow down this path towards the Kahe Generating Station valley.

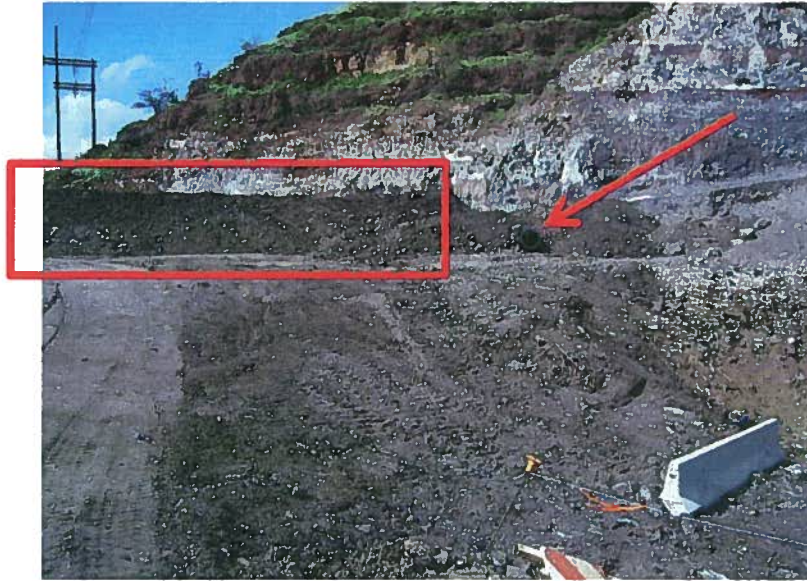
Photograph # 7

7) J. Lottig stated that in preparation for a future rain event, the Landfill had increased the height of the earthen berm/dam on the southwest side of the E6 cell (Photograph 7) and had opened a manhole in the "Hobas" pipe (Photograph 8) which discharges into the Landfill's concrete lined storm drainage channel. A pipe placed as a overflow pipe between the E6 cell and the opening of the Hobas pipe was observed (Photographs 7 and 8). The manhole in the Hobas pipe on the southwest side of the E6 cell was open at the time of inspection; however, no solid waste was observed around the opening to the Hobas pipe.

Description: View of the earthen berm/dam (Red Box) on the southwest side of the E6 cell. Note the "overflow" pipe (Red Arrow) which connects the E6 cell to the opening of the "Hobas" pipe.

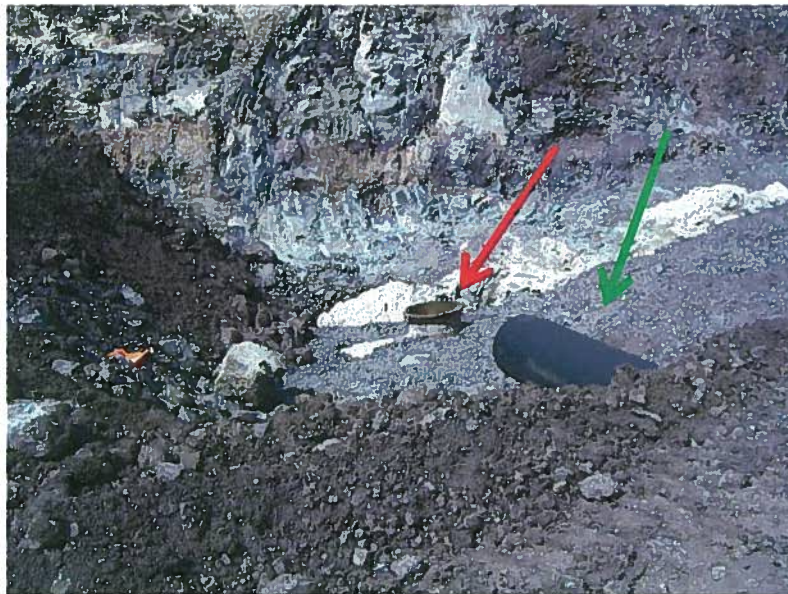
Photograph # 8

8) Discharges from the E6 cell into the Hobas pipe would flow down the Landfill's concrete lined drainage channel and into the Landfill's detention basin before being discharged into the Pacific Ocean. By opening the Hobas pipe and creating a culvert which connected the E6 cell to the open Hobas pipe, the Landfill created a direct connection between the E6 cell and the detention basin.

9) Between December 19, 2010, and December 23, 2010, the Landfill discharged contaminated storm water from the flooded E6 cell. Waste Management representatives stated that the water collected in the E6 cell had been pumped into the opening of the Hobas pipe which was located on the southwest side of the E6 cell (Photograph 8).

Description: View of the manhole in the "Hobas" pipe (Red Arrow). Discharges into the "Hobas" pipe flow down the Landfill's concrete lined channel and into the Landfill's detention basin before being discharged into the ocean. The corrugated pipe (Green Arrow) is the same pipe pictured in Photograph 7.

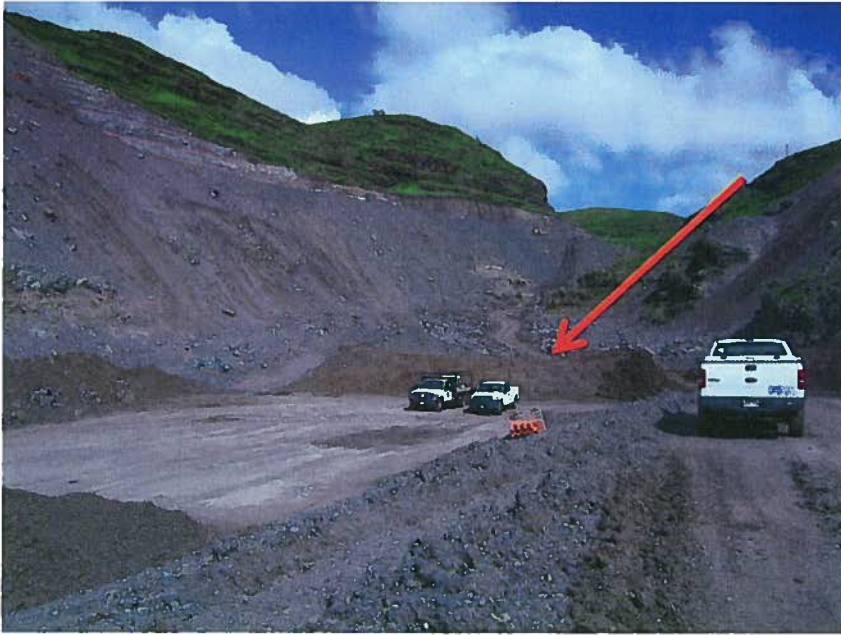
Photograph # 9

10) CWB and EPA representatives inspected the area above the E6 cell (Photograph 9). Large earth moving construction activities were being conducted at the time. Waste Management temporarily suspended the ongoing construction activities so that the 36-inch subsurface storm drain inlet (Photograph 10) could be observed. J. Frey stated that sediment and rocks had deposited around and over the inlet during the December 27, 2010 rain event, effectively burying it as it had during the December 19, 2010 storm event.

Description: View of the area immediately north of the E6 cell. The 36-inch subsurface storm water inlet (Red Arrow) is located behind a berm north of the E6 cell.

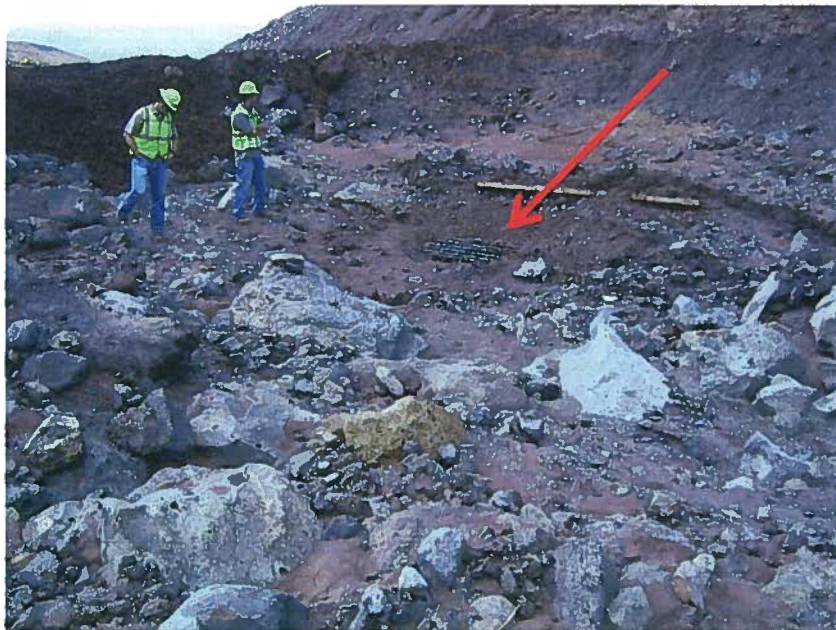
Photograph # 10

11) Waste Management representatives indicated that the reason the E6 cell flooded was because the 36-inch subsurface storm drain inlet had been buried.

Description: View of the 36-inch subsurface storm water inlet (Red Arrow). The grate inlet extends vertically but was buried under a layer of rock and sediment during recent storm events and at the time of inspection.
